S1000RR K67 Window Link Kit Safety Notice

NOTE TO INSTALLER: Failure to properly understand the installation and adjustment modifications listed below WILL result in damage to the motorcycle and potentially lead to a dangerous situation!

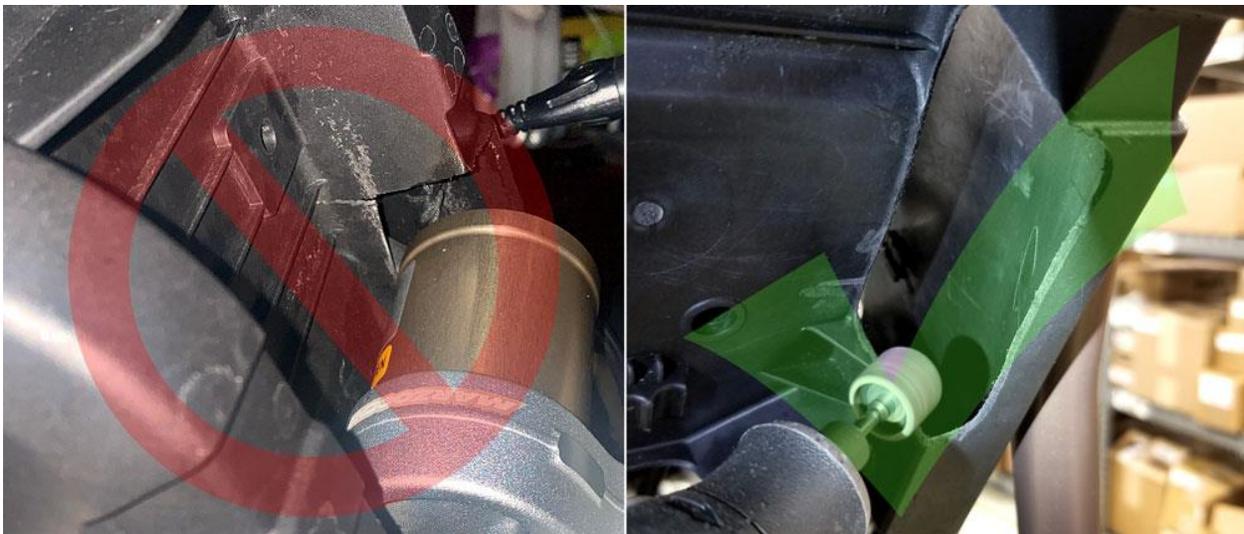
The customer improperly performed the battery tray modification. Insufficient clearance between the shock reservoir and rear fender led to link rod failure.

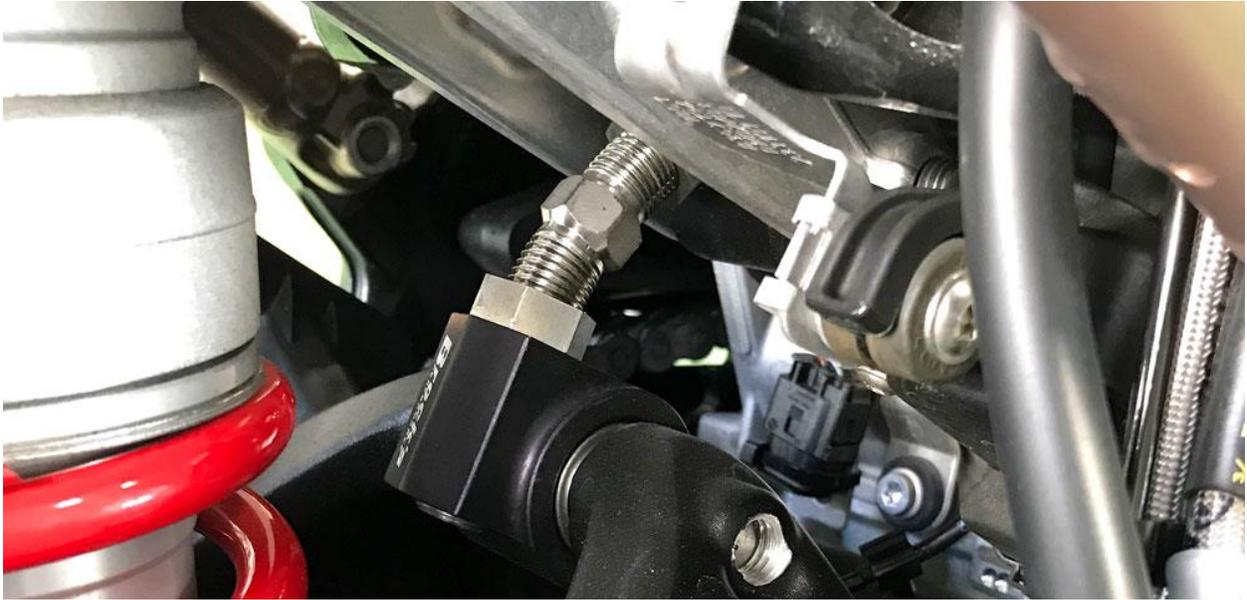
Improper battery tray modification and resulting repeated collisions eventually lead to a bent adjustment rod. If your link rod shows signs of bending DO NOT OPERATE THE BIKE! Find and repair the issue causing the problem and replace the link rod.

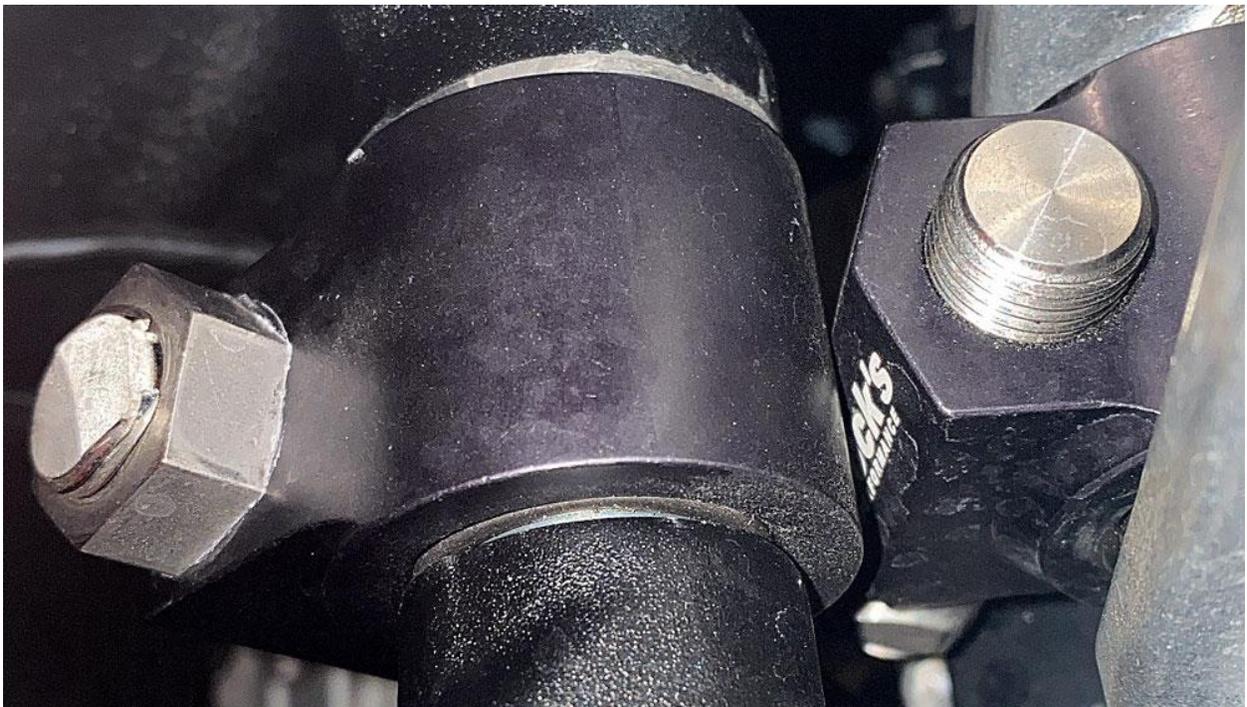
Extreme case of improper battery tray modification and resulting repeated collisions leading to complete adjustment rod failure.

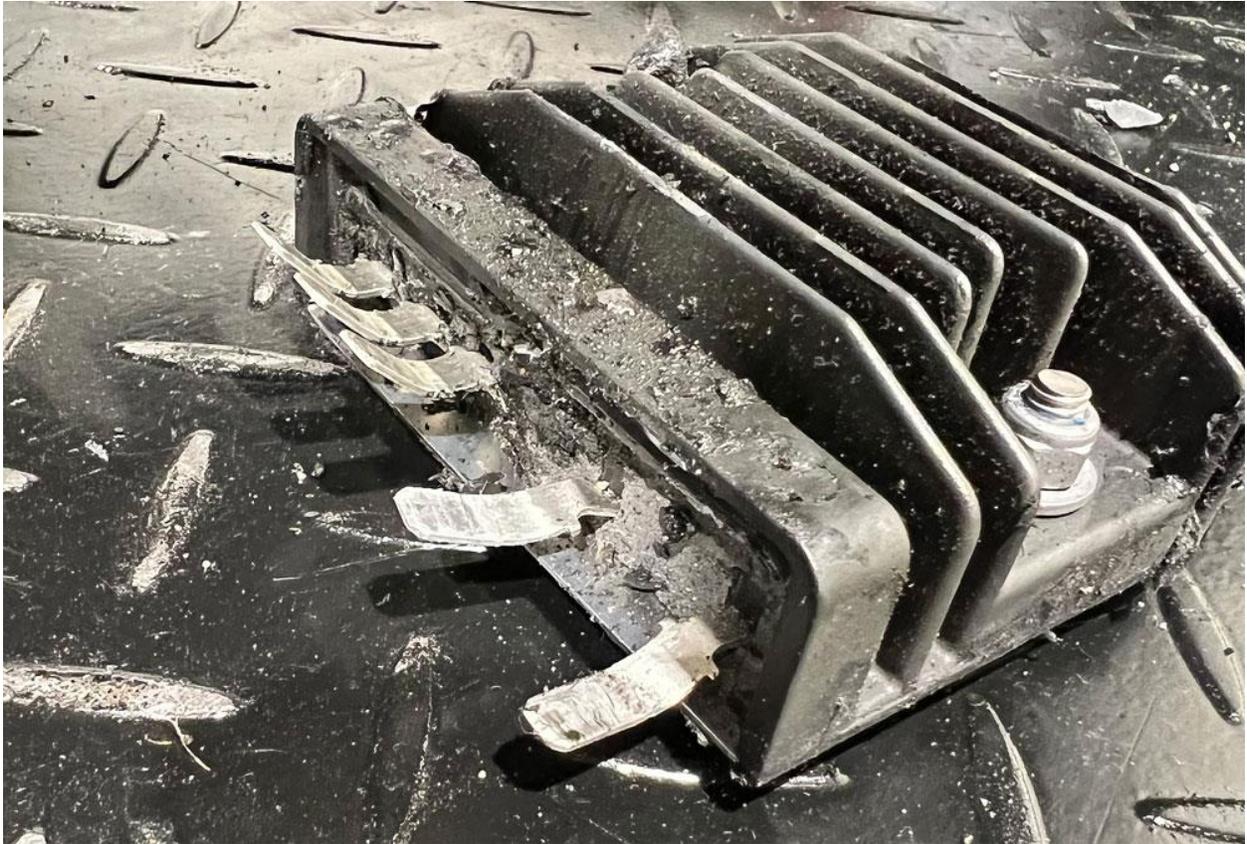
Failure to relocate the voltage regulator resulted in component damage as well as a failed link rod.

The voltage regulator, main fuse, and fuse box **must be relocated**. The battery tray must be **modified** for use with ANY link configuration that **LOWERS THE BIKE AT ALL!**

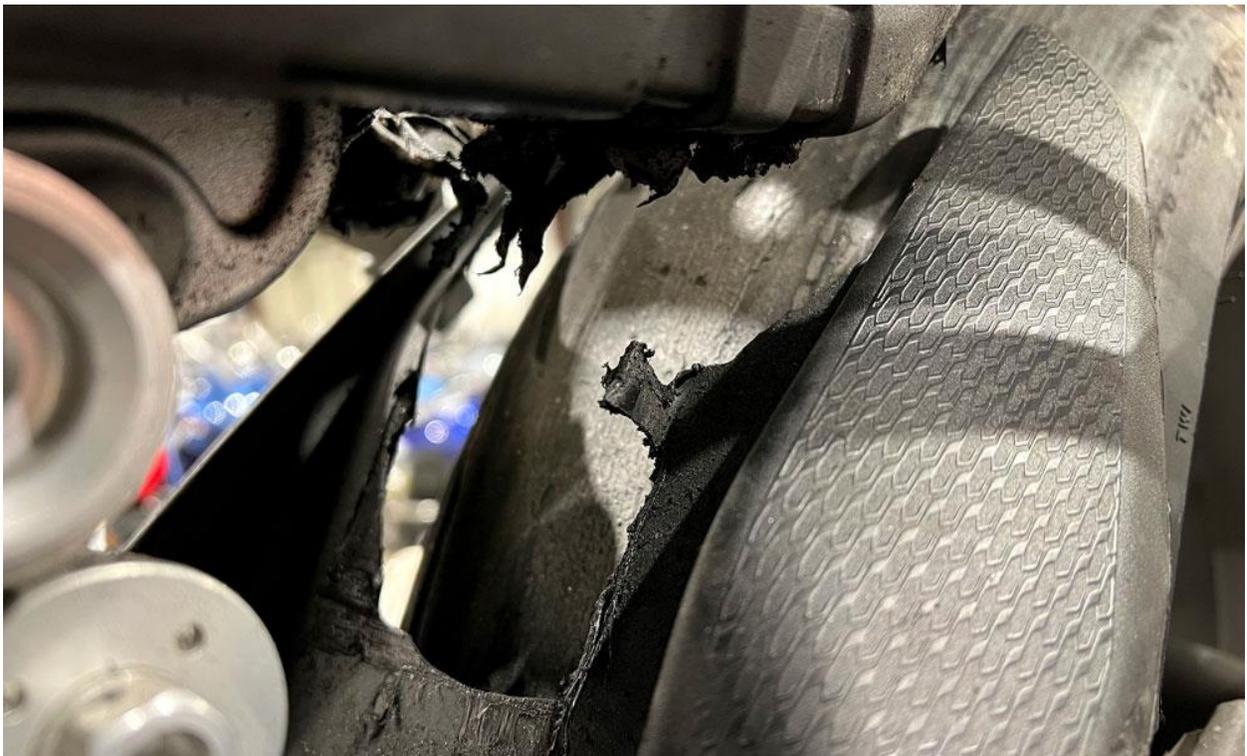
Extreme case of improper adjustment leading to inner fender damage. Inner fender damage, regardless of how minor, is a TALE-TALE sign of an improperly adjusted link. If your inner fender shows signs of the tire melting the plastic or rubbing a hole through — **DO NOT OPERATE THE BIKE!** Inspect the link rod and replace, if required and readjust the link to obtain more clearance. A simple piece of black duct tape over the previous damage will help determine if clearance issues are resolved.

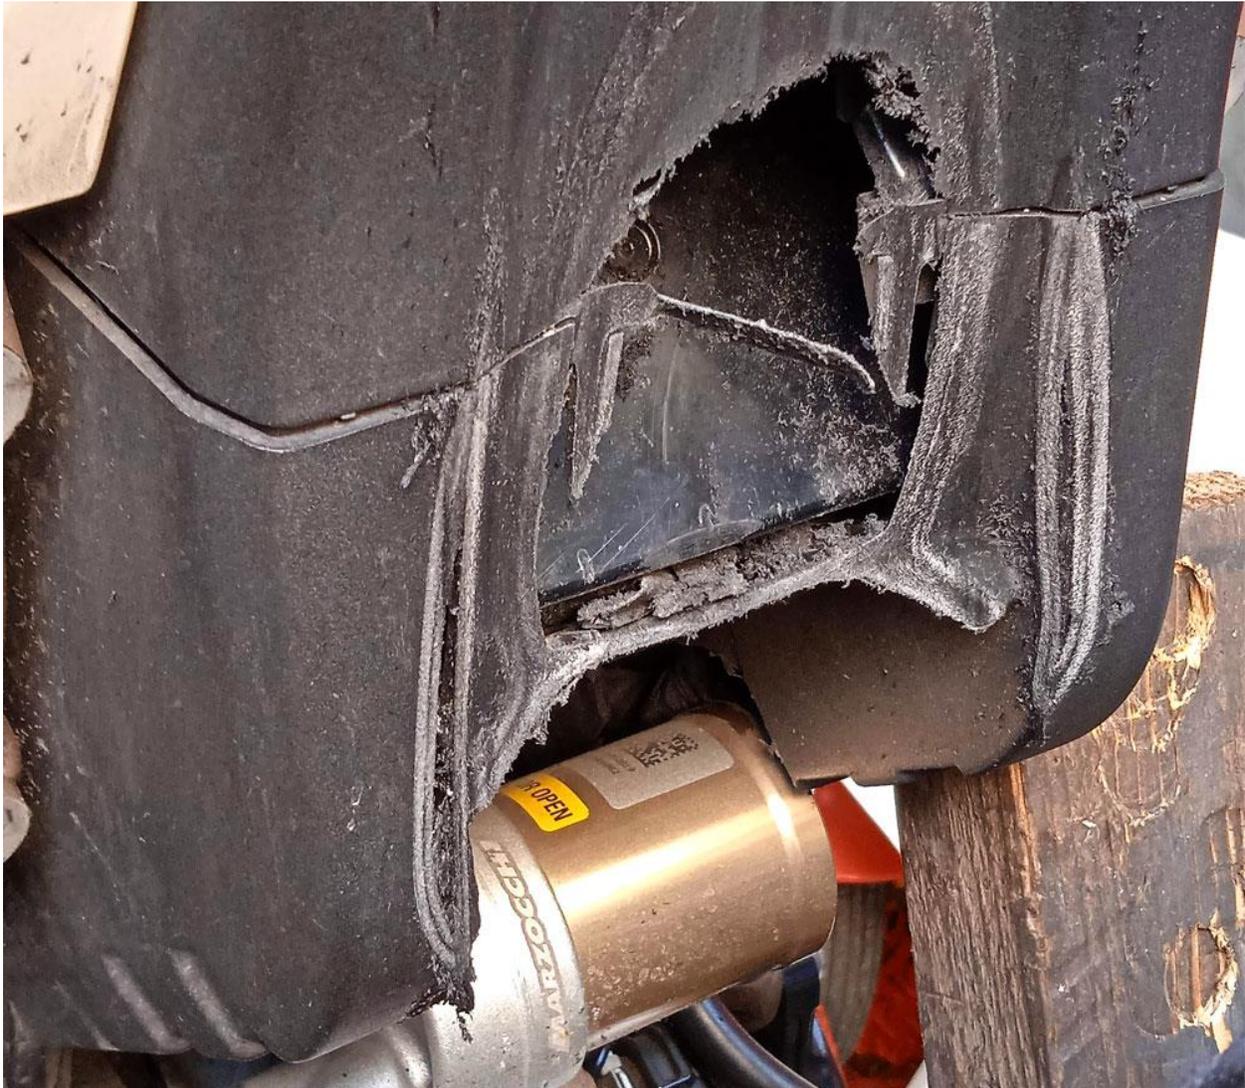
Extreme case of improper adjustment leading to a destroyed inner fender and severely damaged rear fender as well as a snapped link rod and corresponding broken oil pan with lower fairing damage. This situation got way out of hand (and very expensive to repair) due to negligent inspection and lack of action to correct the problem. See Rider Note Above.
